Errata Sheet

Product Family: DL205 Remote Master/Remote Slave

D2-RMSM and D2-RSSS

Manual Number D2-REMIO-M

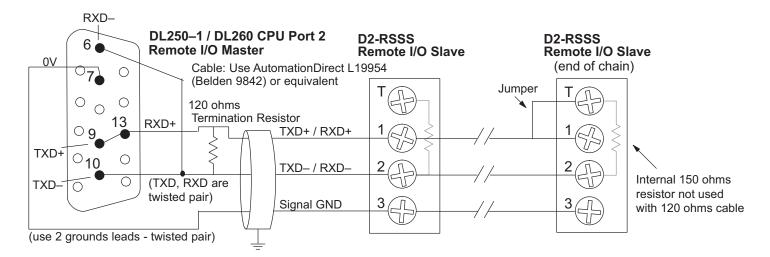
Page 3-8. Step Four: Connecting the Wiring; Cabling Between the D2–250 CPU bottom port and slaves Replace the wiring drawing shown with this one:

The twisted/shielded pair connects to the DL250–1 or DL260 Port 2 as shown. A termination resistor must be added externally to the CPU, as close as possible to the connector pins. Its purpose is to minimize electrical reflections that occur over long cables. A termination resistor must be present at both physical ends of the network.

NOTE: To match termination resistance to AutomationDirect L19827 (Belden 9841), use a 120 ohm resistor across terminals 1 and 2.

Replace the paragraph right after this wiring drawing with this paragraph:
